# Manhole Inspection Summary

Manhole # S25AA1011MH

Insp Date: **2/8/07 10:06 AM**

**Location** Address: **3533 FALLS RD**

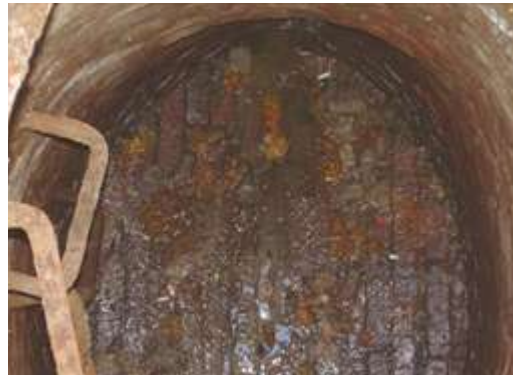
Top View

Corroded steps. Channel debris.

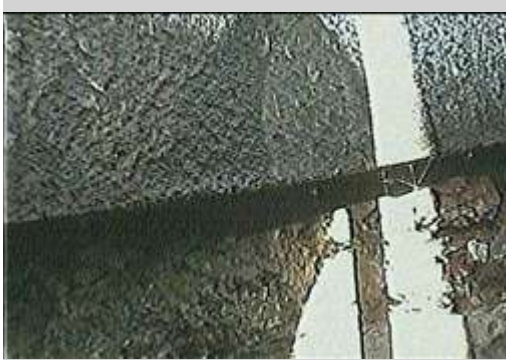
Defect

Frame leaks. Adjustment deterioration and infiltration.

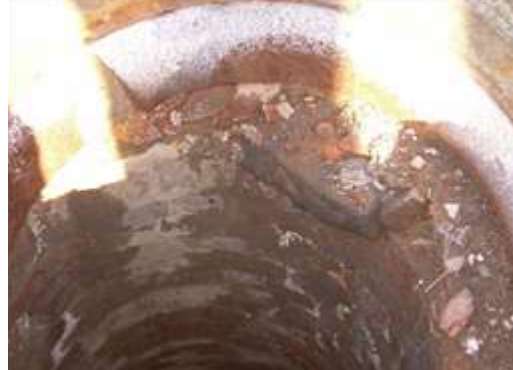
Defect

Adjustment deterioration and infiltration. Corbel and Barrel infiltration.

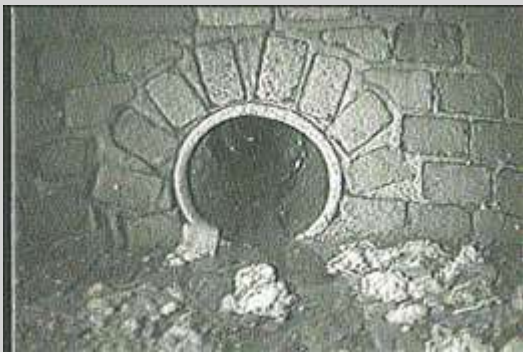
### 8 in. Circular Gravity Sewer Pipe Out @ 12 O'Clock

Comments **The O12 pipe picture shows Barrel deterioration.**

Deposits: ☐ None ☒ **Mud** ☐ Sludge ☒ **Debris** ☐ Grease

Silt Depth: **0.5** (in.) Deposits Extent: **Light**

Infiltration: **Evidence** Pipe Seal Cond: **Unknown**

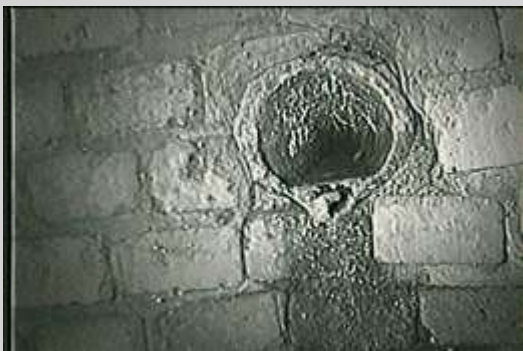
### 4 in. Circular Gravity Sewer Pipe In @ 7 O'Clock

Infiltration: **Evidence** Pipe Seal Cond: **Cracked**
